WETLAND ROAD CROSSINGS HYDROLOGICAL MONITORING DESIGN AND DATA SUMMARY

Final Report

Prepared by:
Pascal Badiou and Bryan Page
Ducks Unlimited Canada
Institute for Wetland and Waterfowl Research
June, 2014

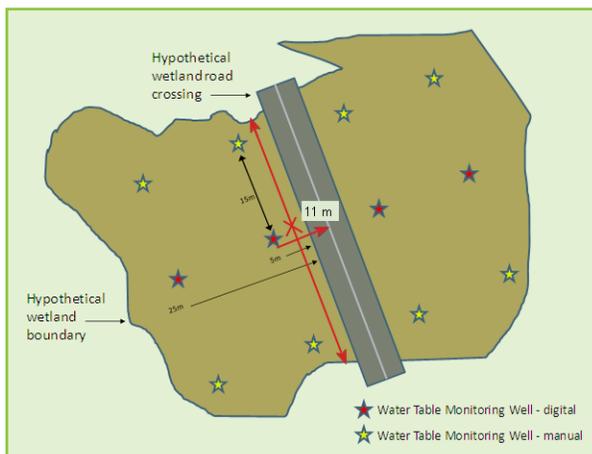
Figure 1. Layout of sampling design showing placement and location of digital and manual water table monitoring wells. Courtesy of Ducks Unlimited Canada.

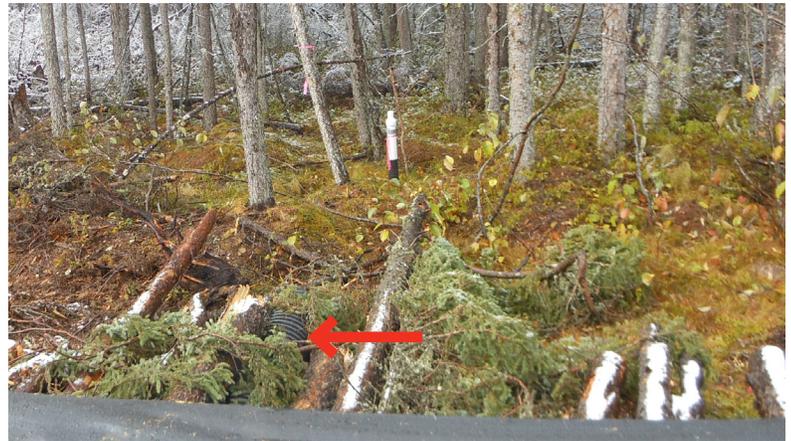
Figure 2. View of a well next to the road. The crossing structure being monitored is a log-corduroy crossing with a plastic culvert (red arrow points to culvert inlet).

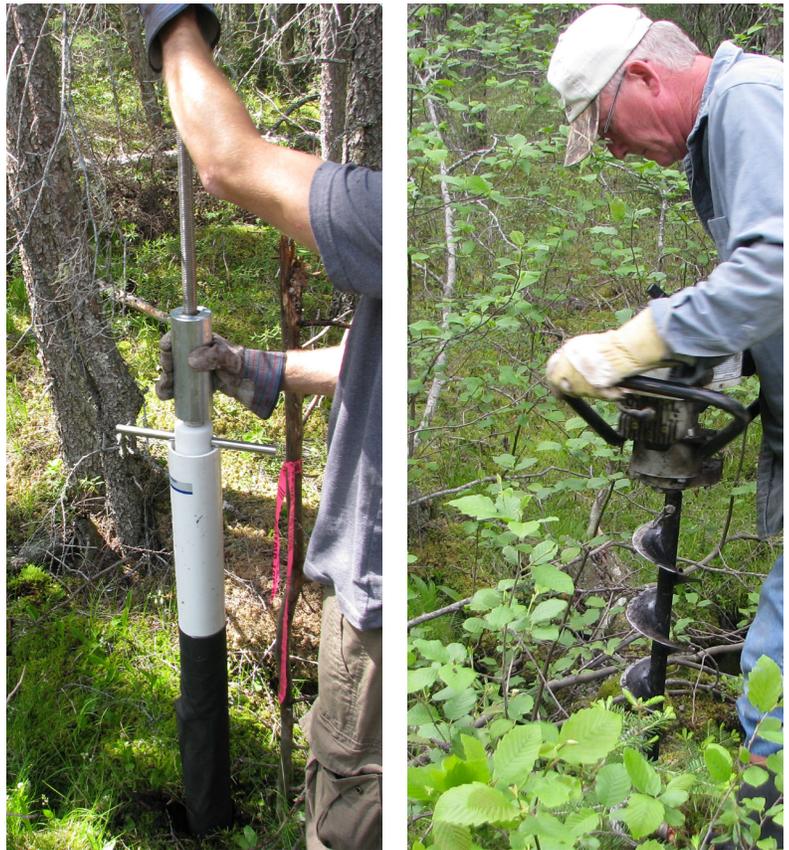
Figure 3. View of the two tools used to install the monitoring wells. A typical pounding tool was used to drive the well tubes into place (left). The job was made easier when a gas-powered auger was used to first create a pilot hole (right).

A pounding tool and a gas-powered auger were both used during the installation of the wells (Figure 3). The pilot hole created by the auger matched the 10cm diameter of the well. The pounding tool provided the downward force to help insert the well into the pilot hole / ground. The wells are made from perforated PVC plastic, have a conical shaped bottom to allow for easier penetration into the ground, and have a removable cap at the top (Figure 4). Wells / PVC pipe were covered with a stretchable fabric cover (sock) to prevent fine material from blocking the numerous small slits / openings along the length of the well. A geotextile fabric can also be used as an alternative to the prepared stretchable fabric covers.

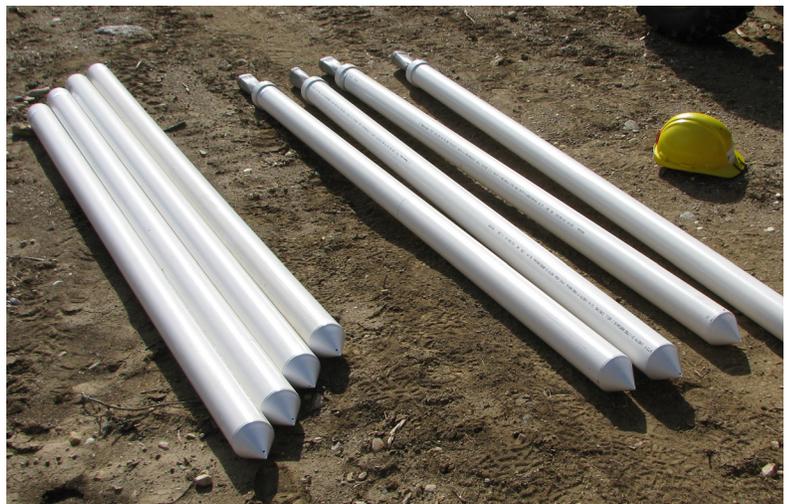
Figure 4. Monitoring wells were made of perforated PVC plastic pipe with conical shaped bottoms. A stretchable fabric sock installed around the pipe (not shown in picture) kept sediment and debris from entering the well through the perforations. Wells had either a removable cap on top to allow for manual water level measurements and sampling (left) or a digital water level recorder as the cap (right).

The digital recorder used at the monitoring sites is an RDS Ecotone® WM Water Level Instrument designed for the measurement of shallow ground and surface water levels. The recorder combines the data logger, water level sensor and custom well screen (sock) in one package. The purchase cost for these units varies by water level sensor range; the range is from 0.5 m to 2.0 m. The cost is approximately \$750 to \$1050.
